The following is the complete official USAF Mishap [Safety Board] Report regarding the 18 January 1982 Thunderbird Diamond accident occurring at what was then called the Indian Springs Air Force Auxiliary Field in Indian Springs, Nevada. This report was requested under the FOIA program and was received redacted IAW AFR 91-204. It should be noted that at the time of this incident AFR 127-4 was in effect. This PDF's text and image quality matches that of the paper copy received. The FOIA requestor was informed that it was complete, and the best copy available. The Board identified the cause of the accident by typing (CAUSE) next to one of the findings on the last page of the report.

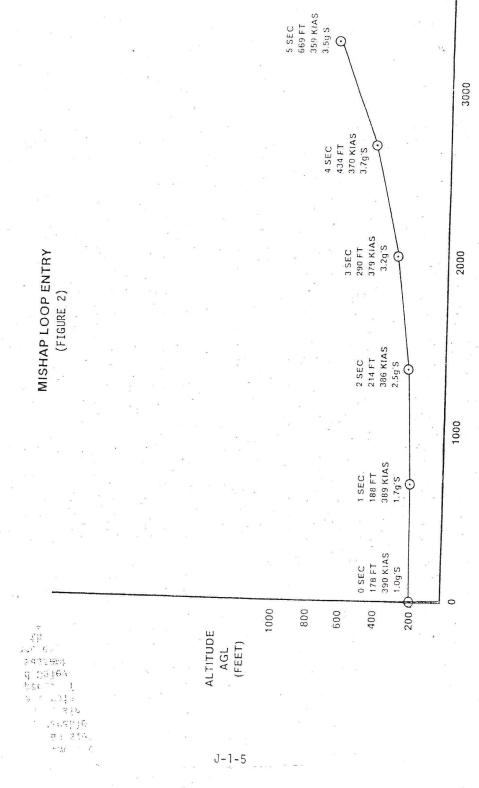
TABLE I

MISHAP LOOP ENTRY CONDITIONS

Time From Pull-Up	Alt AGL	Est Vel	Fit Path Angle	Gs
(Seconds)	(Feet)	(KIAS)	(Degrees)	
0	178	390	0	1.0
1	188	389	1	1.7
2	214	386	4	2.5
3	290	379	9	3.2
4	434	370	16	3.7
5	669	359	26	3.5
